Furness PathFix Surveyor's Report

Path Number: 602052 Marton - Ireleth	Start Location Ref: 54°11'05.2"N 3°09'55.4"W	Finish Location Ref.: 54°11'17.1"N 3°11'26.3"W
OS map of whole route showing locations of furniture/assets

23 assets surveyed and recorded!
Date survey carried out: Wednesday 28 May 2025	Time:	Surveyor's Names: Simon Baxter & Linda Marshall
Furniture/Assets		
Finger Post No.: 1 54°11'05.2"N 3°09'55.4"W

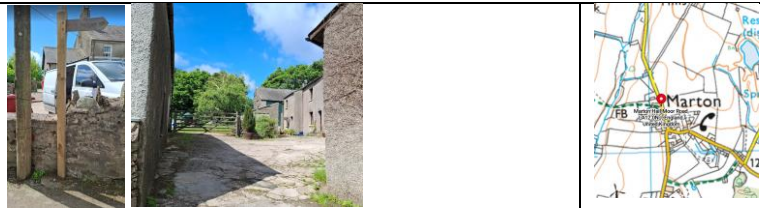
Assessment:	Adjacent to road; good condition; stable. Points into farm yard but no indication regarding direction after that. Five bar gate directly ahead tempts walkers to go through this but they will be in the field to the left of the boundary. Footpath goes to the right of a sloping roof small outbuilding, accessing field through a small iron gate into the field beyond.	
Recommended Action:	Approach owner of farm for permission to place a way marker on the side of the aforementioned outbuilding

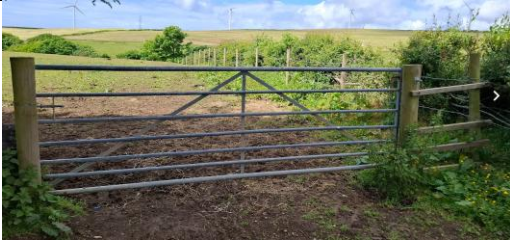
Possible Risk Factors/hazards:	Possible hazard due to holes in metal post	
Additional comments:		
Gate No.: 2 54°11'05.6"N 3°09'59.9"W

Assessment:	Metal livestock gate for access into field owned by Graham Dobson. Able to easily open. No way mark indicating direction once through the gate.	
Recommended Action:	None considered needed	
Action completed:		
Vehicular Access:	From road	
Health and safety issues:		
Possible Risk Factors/hazards:		
Additional comments:		
Gate No.: 3 54°11'05.4"N 3°10'05.2"W
